# New PSU Sensor Design and Cable Seal Fabrication Procedures

M. D. JEVNACER AND J. L. TINS

February 9, 1982

NAVAL RESEARCH LABORATORY  
Washington, D.C.

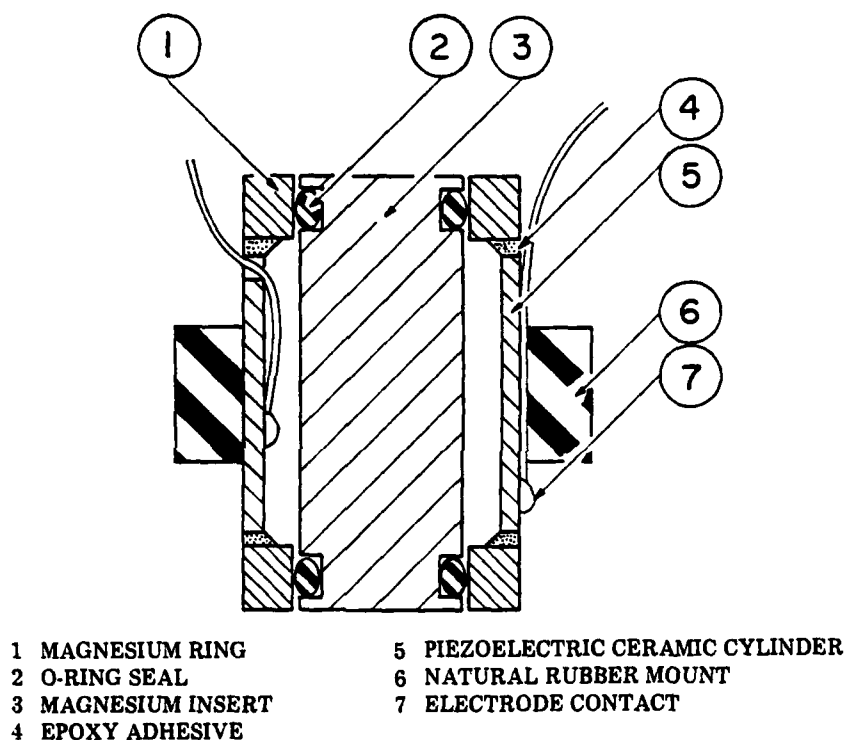
Fig. 2 — Section through the sensitive element

A careful study of flooded sensitive elements (Fig. 2) showed several reasons for the failures, most of which involved the O-ring seals. Some of the O-rings were sheared due to improper assembly procedures, or the magnesium ring had such a large chamfer that the O-ring had insufficient surface to seal on. Poor bonding, probably due to inadequate cleaning, allowed some of the magnesium end rings to come off easily, and could have leaked under pressure as well.

Proper O-ring installation, good bonding between the ceramic and the magnesium, and potting of the sensitive elements with suitable elastomers should keep them from flooding with oil. Adherence to a proper assembly procedure for the cable gland should prevent hermetic seal failures.

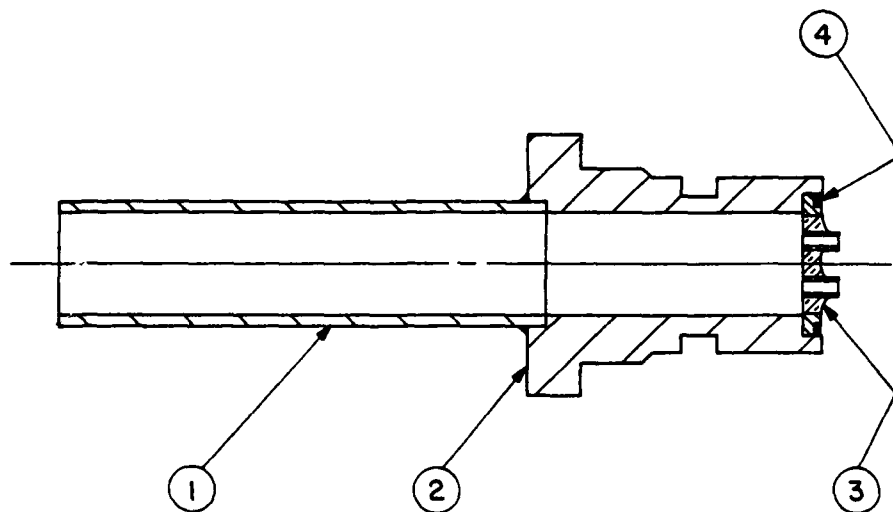
Fig. 3 — Section through the cable gland metal subassembly

A study of the glass-to-metal seal in the cable gland (Fig. 3) showed a variety of problems, most of which concern installation. Many were installed with epoxy or were cold soldered after the cable was installed. Both of these methods cause leaks, allowing oil to migrate up the cable. The epoxy method is not according to the specifications for the cable gland assembly. The cold solder method is an improper assembly procedure that also does not meet the specifications.

Many cable glands electrically short-out due to flux etching the glass seal material between terminals or between a terminal and the rim. The etching can also weaken the glass enough for it to break under pressure. Excessive heat applied trying to solder the seal in after the cable is installed can melt the insulation off the leads.

No design change has been made in the cable gland hermetic seal, but the following fabrication procedure must be adhered to.

Degrease the cable gland metal subassembly and then place it in a suitable fixture on a hot plate. The fixture should support the part upright and expose the cup which accepts the hermetic seal; the fixture should be of metal to transfer heat properly. Heat the metal subassembly to approximately 200°C. Use a stainless steel flux (usually highly acid) and solder without a flux core (see Appendix A - Type 1) to tin the cup in the subassembly, completely, but not excessively. After the solder has solidified, but while the assembly is still hot, rinse and wash it using lots of water. Reheat and then spread the tinned layer around some more to be sure it has completely wet the surface and no stainless flux remains. Thoroughly rinse, wash again, and dry.

Examine the hermetic seal for physical damage and measure the electrical resistance from each terminal to the rim. If the electrical resistance is low, clean as required to raise the resistance to  $>10^{11}$  ohms. Reheat the metal subassembly and place the seal in the cup. Using a clean soldering iron, apply special alloy solder (see Appendix A - Type 2) to fill and complete the hermetic seal. Remove the fixture and subassembly from the hot plate, and place on a heat sink to cool. After it has cooled to ambient room temperature, rinse and wash again to clean off any soldering flux that may still be present. Repeat several times; it cannot get "too clean". Dry, and check the resistance to be sure electrical resistance has been maintained and that the seal has not been fractured. Prepare the end of the cable that goes into the cable gland, as shown in Fig. 5. Strip the cable back to expose approximately 13 cm of bare leads. Pull on the leads to straighten them and then tin them full length with TYPE 2 special alloy solder. Clean the excess flux off the leads and cut one lead approximately 1.5 cm shorter than the other. Insert the tinned leads through the terminals in the seal. Insert
